Manhole Inspection Summary

Manhole # S53S1_003MH

Insp Date: **6/3/08 10:20 AM**

Location Address: **1920 Frankfurst Ave.**

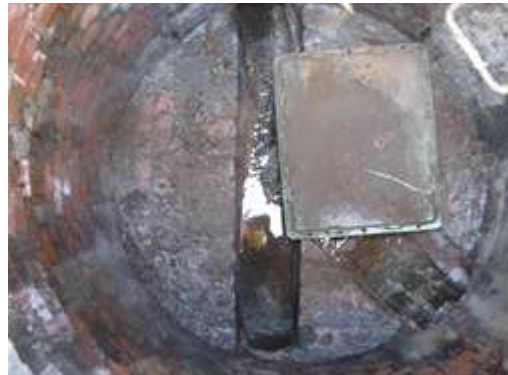
Top View

Condition: ☐ Sound ☐ Cracked ☐ Root Intrusion ☐ Deteriorated ☐ Leaks ☒ **Debris**

Foreign object is blocking some portion of the channel.

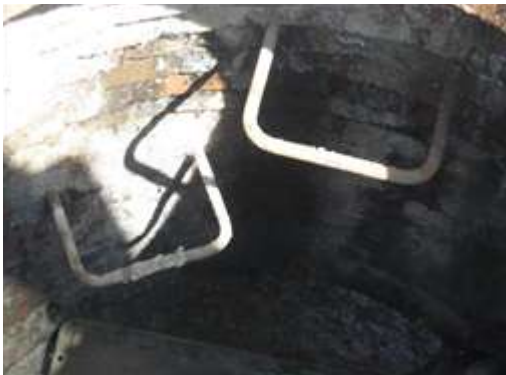
Steps

Count: **2** Missing: **0** ☒ **Corroded**

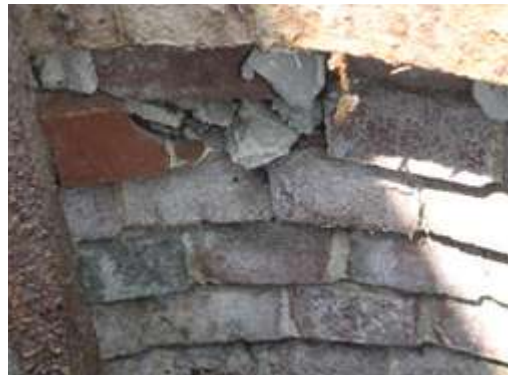
Defect 2

Condition: ☐ Sound ☒ **Cracked** ☐ Root Intrusion ☐ Loose Brick ☐ Deteriorated

Cracked Corbel.

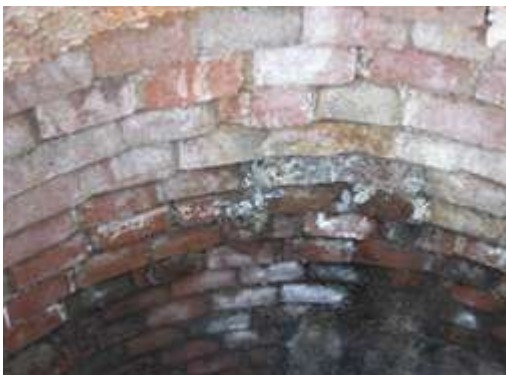
Defect 1

Infiltration: ☐ None ☐ Joint ☐ Cracks ☐ Mortar ☐ Roots ☒ **Wall**

Infiltration

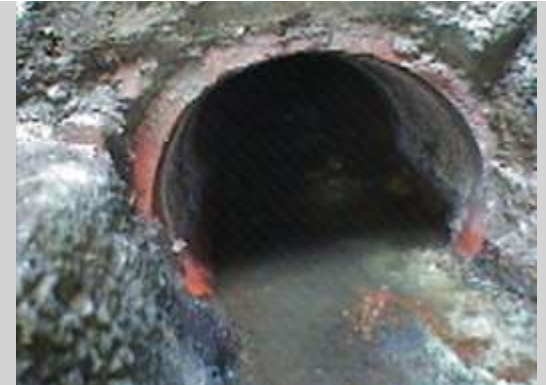
12 O'Clock Outflow

8 in. Circular Gravity Sewer
Pipe Out @ 12 O'Clock

Pipe Height: **6** (in.) Rod and Bar (Angled)
Pipe Material: **Clay** ☐ Pipe Lined
Invert Depth: **6.28** (ft.) Flow Characteristics: **Slow**
Deposits: ☒ None ☐ Mud ☐ Sludge ☐ Debris ☐ Grease
Silt Depth: (in.) Deposits Extent:
Infiltration: **None** Pipe Seal Cond: **Sound**

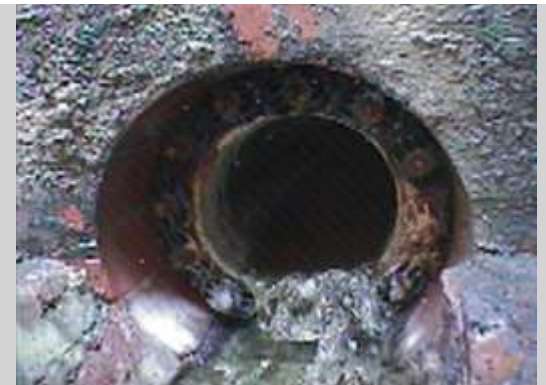
5 O'Clock Inflow

6 in. Circular Gravity Sewer
Pipe In @ 5 O'Clock

Pipe Height: **7.2** (in.) Rod and Bar (Angled)
Pipe Material: **PVC** ☐ Pipe Lined
Invert Depth: **6.00** (ft.) Flow Characteristics: **Slow**
Deposits: ☐ None ☐ Mud ☒ **Sludge** ☐ Debris ☐ Grease
Silt Depth: **1** (in.) Deposits Extent: **Light**
Infiltration: **None** Pipe Seal Cond: **Sound**

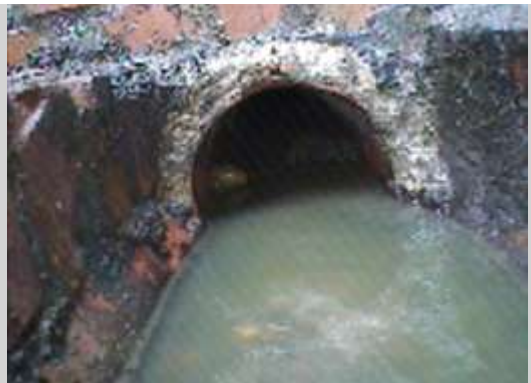
6 O'Clock Inflow

6 in. Circular Gravity Sewer
Pipe In @ 6 O'Clock

Pipe Height: **4.8** (in.) Rod and Bar (Angled)

Pipe Material: **Clay** ☐ Pipe Lined

Invert Depth: **6.10** (ft.) Flow Characteristics: **Slow**

Deposits: ☒ None ☐ Mud ☐ Sludge ☐ Debris ☐ Grease

Infiltration: **None** Pipe Seal Cond: **Sound**
